Manhole Inspection Summary

Manhole # S17GG2012MH

Insp Date: **10/4/06 1:35 PM**

Location Address: **5921 SMITH AVE**

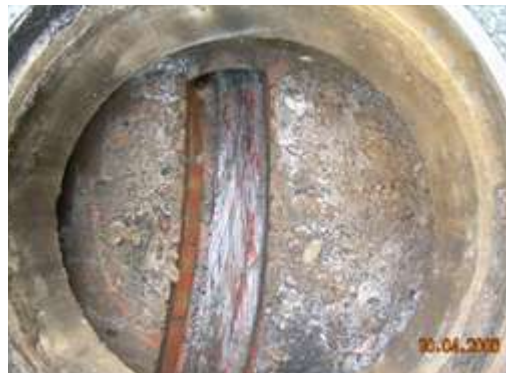
Top View

Frame leaks. Corbel infiltration. Evidence of surcharge - Bench debris.

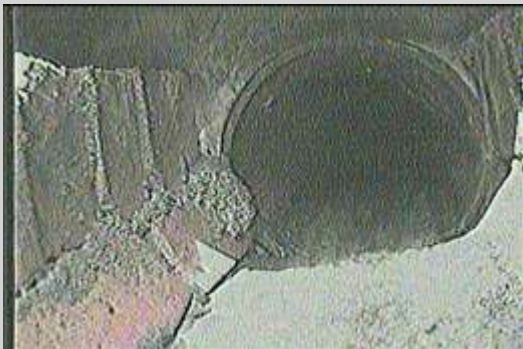
8 in. Circular Gravity Sewer Pipe In @ 7 O'Clock

Channel deterioration.

Infiltration: **Evidence** Pipe Seal Cond: **Unknown**
